## **PTH 12 and PR 210 In-Service Road Safety Review and Design Process**

# In-Service Road Safety Review

*Summary of the findings from an in-service road safety review of the stop-controlled intersection of PTH 12 and PR 210 conducted for Manitoba Transportation and Infrastructure.*

August 8, 2023

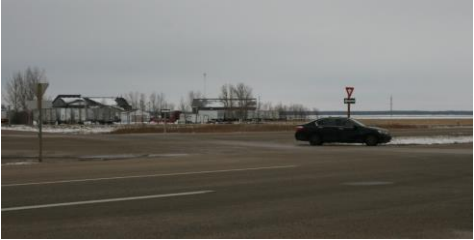
| Comment #1 | |

| Comment #1 | |
|---|--|
| <p><b>Concern</b></p> <p>The narrow median width at this intersection limits the available storage and refuge area for vehicles using the median as a two-stage crossing. Of particular concern is the accommodation of long and heavy trucks which accounted for 7% of 2020 traffic volumes at this intersection.</p> <p>Trucks entering from the sideroad have to use the intersection as a single stage crossing and must ensure the median is clear prior to advancing. Trucks cannot stop in the median without potential conflict with other traffic movements.</p> | <p style="text-align: center;"><i>Narrow Median Width</i></p> |

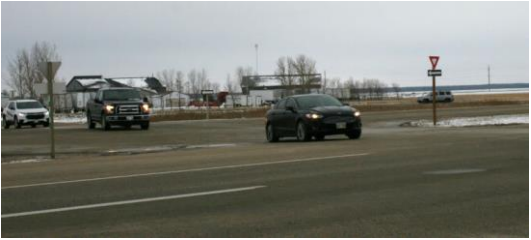
| Comment #2 | |

| Comment #2 | |
|---|--|
| <p><b>Concern</b></p> <p>Several vehicles were observed stopping in the median at the same time. This results in several conflict scenarios, including conflict between vehicles with conflicting orientation waiting in the median, and potential for queuing traffic to extend into the high speed through lanes.</p> | <p style="text-align: center;"><i>Several vehicles attempting to access median at same time</i></p> |

| Intersection Element | Road Safety Observations | Site Investigation | Safety Analysis | | | | |
|---|--|---|---|---|---|---|---|
| | Several vehicles were observed stopping in the median at the same time. This results in several conflict scenarios, including conflict between vehicles with conflicting orientation waiting in the median, and potential for queuing traffic to extend into the high speed through lanes. | X | X | X | | X | X |

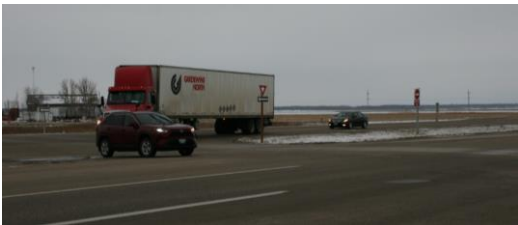
| Comment #3 | |

| Comment #3 | |
|---|---|
| <p><b>Concern</b></p> <p>The PTH 12 left-turn lanes have a negative offset which can limit sightlines for opposing left-turning vehicles. Of particular concern is when vehicles are stopped in the median to perform a two-stage crossing and trucks turning left from mainline lanes must wait at the left-turn deceleration lane for the median to clear before turning.</p> | <p style="text-align: center;"><i>Truck making northbound left blocking access to the median</i></p> |

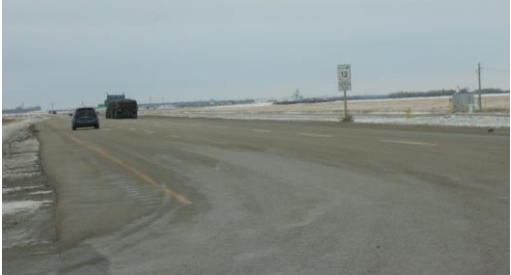
| <b>Comment #4</b> | |

| <b>Comment #4</b> | |
|---|---|
| <b>Concern</b> | <p><i>Southbound left-turn acceleration lane</i></p> |
| <p>The southbound left-turn acceleration lane appears short. Observation from the site review suggest that vehicles merging from the acceleration lane into the high-speed mainline lane do so at speed of approximately 70-80 km/h. This can result in significant speed differential with through traffic at this location.</p> <p>This is of particular concern for larger trucks that generally take longer to accelerate, thus merging at much lower speeds.</p> | |

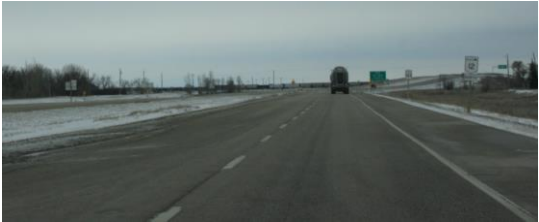
| <b>Comment #5</b> | |

| <b>Comment #5</b> | |
|---|---|
| <b>Concern</b> | <p><i>Existing northbound lanes (north of intersection)</i></p> |
| <p>Field observations suggest a significant volume of trucks are turning left from eastbound PR 210 onto northbound PTH 12. No left-turn acceleration lane is provided for this movement. As a result, these trucks are merging directly into the high-speed mainline lane. This introduces significant speed differentials and an increased risk of collision.</p> | |

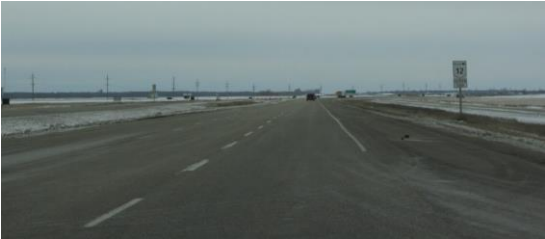
| <b>Comment #6</b> | |

| <b>Comment #6</b> | |
|---|--|
| <b>Concern</b> | <p><i>Existing southbound lanes (south of intersection)</i></p> |
| <p>Field observations suggest a significant volume of trucks (26% of 2020 truck turning traffic) is turning right onto southbound PTH 12 from eastbound PR 210. No right-turn acceleration lane is provided for this movement. As a result, these trucks are merging directly into the mainline lane. This introduces significant speed differentials and an increased risk of collision.</p> | |

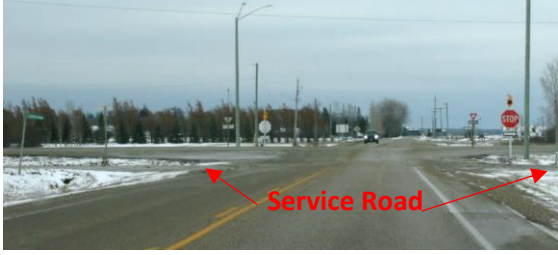
| <b>Comment #7</b> | |

| <b>Comment #7</b> | |
|---|--|
| <p>An intersection with the adjacent service road west of PTH 12 is located in close proximity to the main intersection (PTH 12 / PR 210). The close proximity of this intersection may cause conflicts between through traffic and vehicles turning to/from the service road, especially if there are eastbound queues at the intersection. During the site visit, eastbound queues were observed to be less than three vehicles long (commonly only one or two queuing vehicles were observed).</p> | |

*Service Road west of intersection*

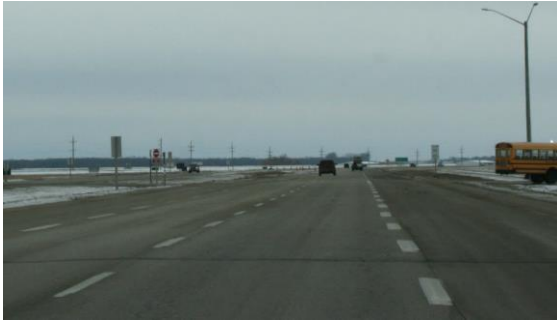
| <b>Comment #8</b> | |

| <b>Comment #8</b> | |
|---|---|
| <p>Dashed line painting immediately in advance of the intersection may encourage drivers to perform a passing manoeuvre in advance of the intersection.</p> | |

*Dashed line on approach in advance of the intersection*

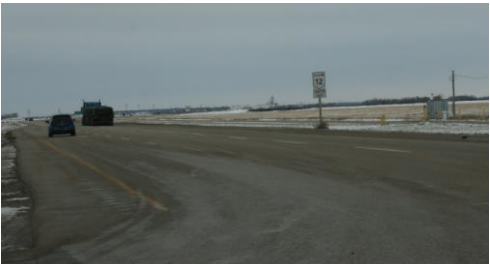
| <b>Comment #10</b> | |

| <b>Comment #10</b> | |
|---|--|
| <p><b>Concern</b></p> <p>During the site investigation, there were a few instances where vehicles pulled directly into the mainline travel lanes or only used the acceleration lane for a short distance. The southbound acceleration lane is delineated with dashed lines, this may encourage drivers to merge into the high-speed mainline lane shortly after entering the acceleration lane. This may result in significant speed differentials and potential for high-severity conflicts.</p> | <div style="text-align: center;"> </div> <p style="text-align: center;"><i>Southbound acceleration lane</i></p> |

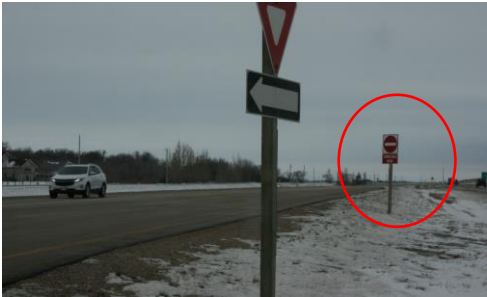
| Comment #11 | |

| Comment #11 | |
|---|--|
| <b>Concern</b> | |
| <p>Wrong Way signs are not double posted on the mainline lanes north and south of the intersection.</p> | |

*Wrong Way sign in median*

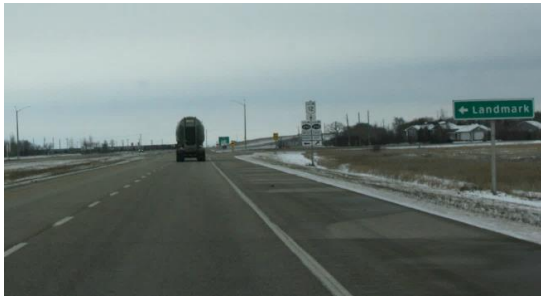
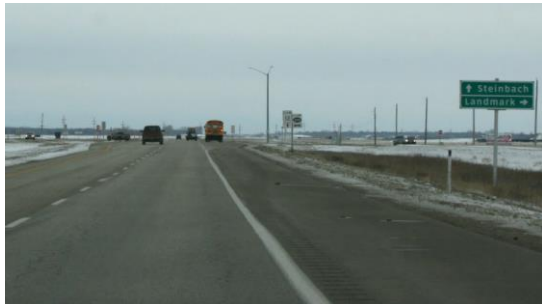
| Comment #12 | |

| Comment #12 | |
|---|---|
| <p>Guide signage on the northbound and southbound approaches to the intersection does not appear to be consistent.</p> <p>On the northbound approach, an advance guide sign is missing. The intersection guide sign provides information for the westbound direction only, and the sign appears to be located too far in advance of the intersection.</p> <p>In the southbound direction, an advance guide sign is missing.</p> | |

*Northbound approach to the intersection*

*Southbound approach to the intersection*

- Pavement edge and lane line painting is deteriorated and missing in some instances.
  - Several inconsistencies in the advanced guide signage offered to drivers were observed.

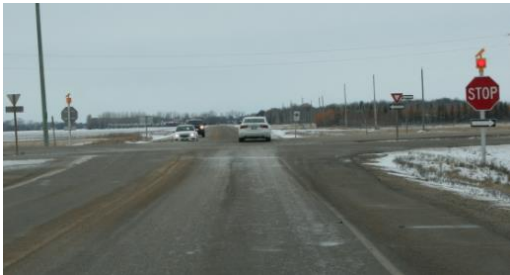
| Comment #13 | |

| Comment #13 | |
|---|--|
| <b>Concern</b> | |
| <p>Due to the wide median opening, the yield signs in the median are located at an increased offset from the travel path. As a result, the effectiveness of these signs may be reduced.</p> | |

*Yield signs in median appear small*

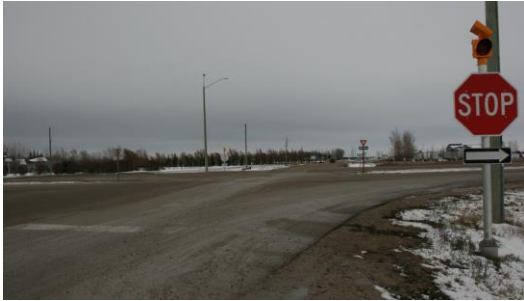
| Comment #16 | |

| Comment #16 | |
|--|--|
| In general, line painting is deteriorated. As a result, delineation within the intersection is poor. This contributes to increased driver workload and risk of driver error. | |

*Pavement marking deterioration*

- The positive guidance offered to drivers is limited and may contribute to increased workload and the potential for driver error. Examples include:
  - Stop bar line painting is deteriorated.

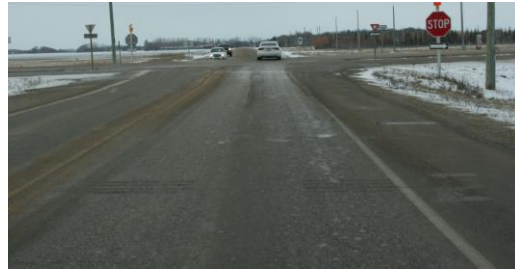
The rumble strips on the westbound approach to the intersection are worn in the wheel paths. This may impact their effectiveness. It is our understanding that this feature has been installed as a “low noise rumble strips” treatment.

*Rumble strips on the westbound approach*

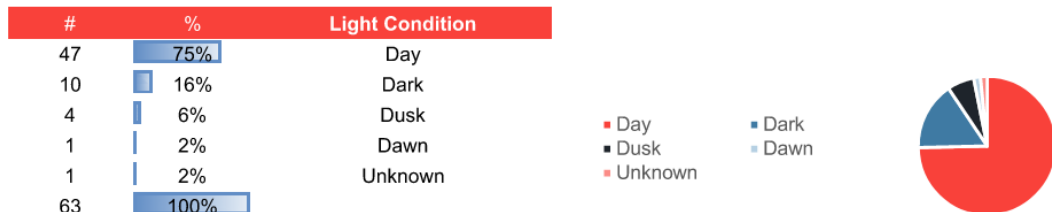
Figure 4.2.4: Lighting Conditions

**Light Condition:** A total of 15 (24%) collisions occurred during periods of reduced lighting levels (dark, dusk or dawn).

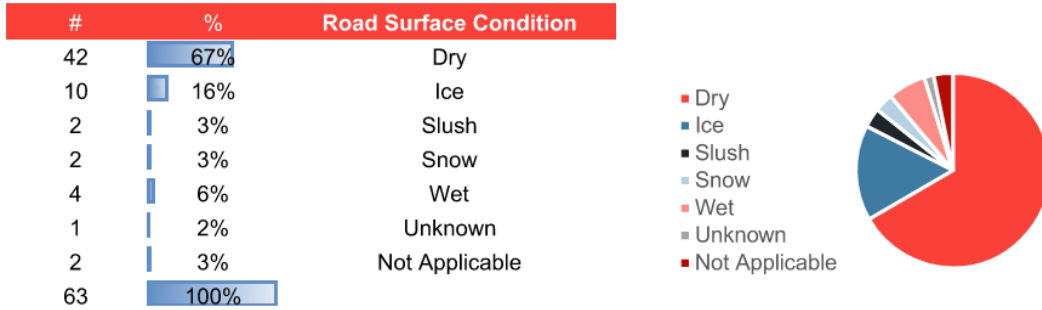
Figure 4.2.5: Road Surface Condition

**Road Surface Condition:** Ice, slush, snow and wet road surface conditions were present in 18 (28%) of reported collisions and half of these collisions resulted in an off-road collision or fixed-object collision. 67% of the collisions occurred during dry road surfaces condition.

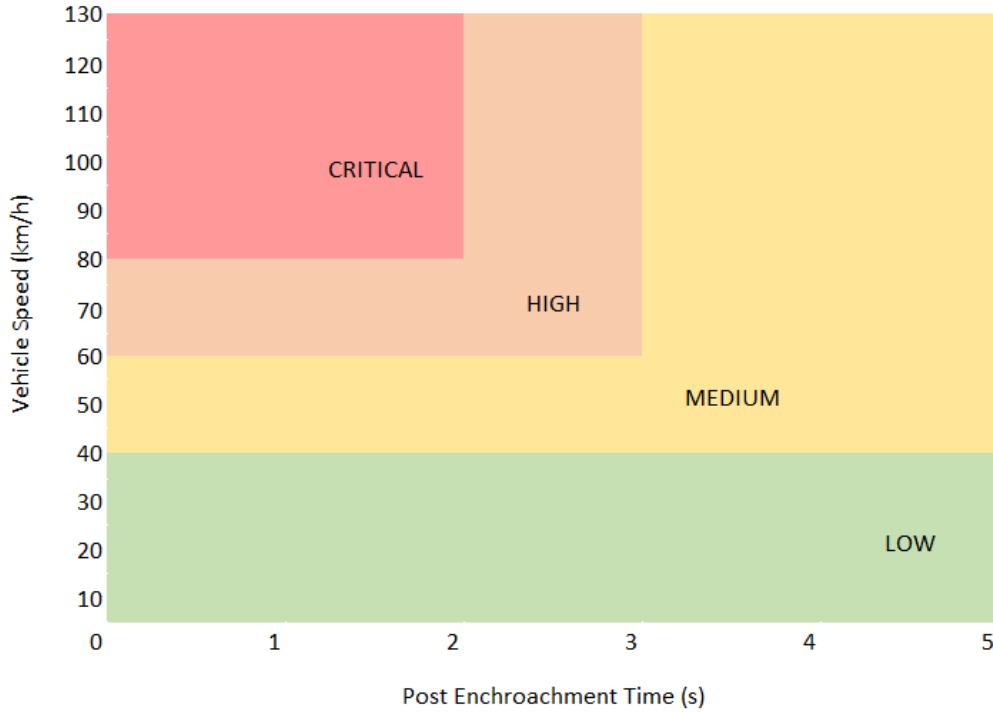
Figure 4.5.1: Risk Level Categories

To quantify the level of risk present at this intersection, the ten crossing conflicting movements identified at the intersection were individually analyzed and assigned a risk level based on the PET value and maximum speed of vehicles involved in the conflict. The risk rating was performed using risk level categories indicated in **Figure 4.5.1** and **Table 4.5.2** below.

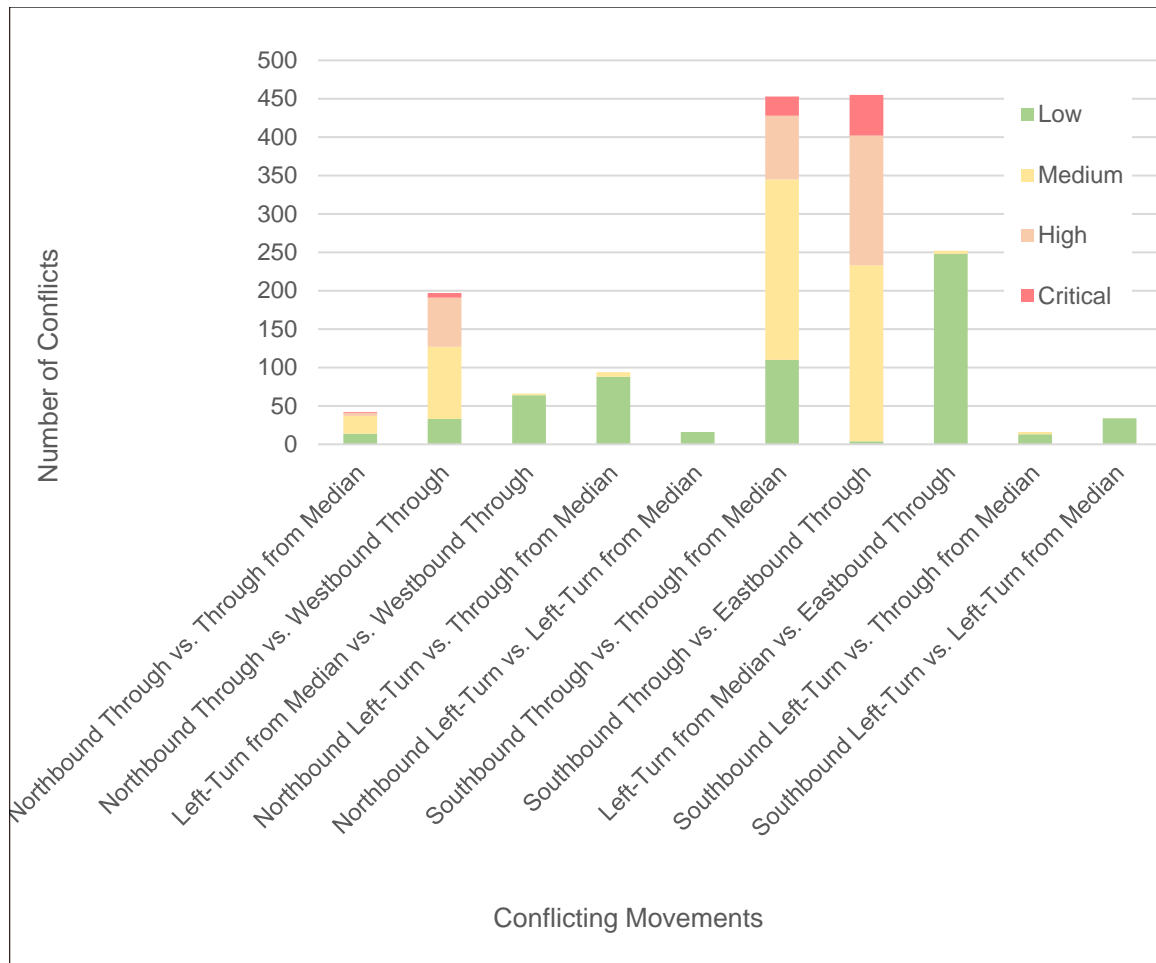
Figure 4.5.2: Summary of Risk Level Rating for Crossing Conflicts

| | Conflicting Movements | Crossing Conflict Type | Total Number of Crossing Conflicts | Number of Crossing Conflicts for PET < 5 sec | Risk Level Rating | | | | |
|---|--|--|---|--|---|---|---|---|---|
| 10 | Southbound Left-Turn vs. Left-Turn from Median | | Left-Turn vs. Left-Turn from Left | 73 | 34 | 0 | 0 | 0 | 34 |

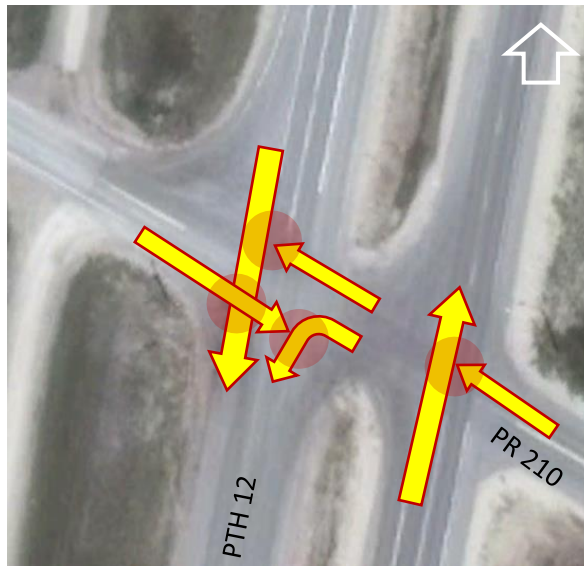
Figure 4.5.3: The most frequent crossing conflicts

- The most frequent conflicts are those occurring at the west part of the intersection. This is illustrated in **Figure 4.5.3** below.

- The highest frequency of conflicts involved the following movements:
  - Southbound Through vs. Eastbound Through,
  - Southbound Through vs. Westbound Through from Median,
  - Eastbound Through vs. Left-Turn from Median, and
  - Northbound Through vs. Westbound Through
- The highest number of critical-risk conflicts involved the following two movements:
  - Southbound Through vs. Eastbound Through, and
  - Southbound Through vs. Westbound Through from Median

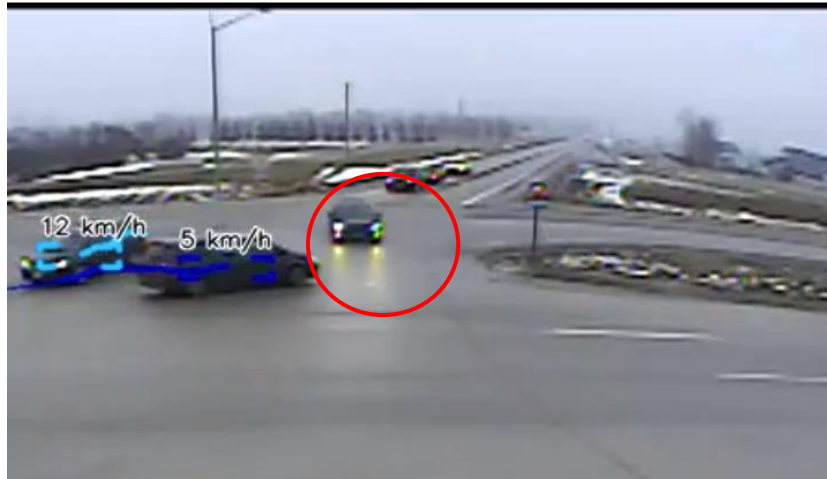
*Figure 4.5.4: Median occupied by multiple vehicles*

- The Northbound Through vs. Westbound Through movements resulted in significant number of medium-risk and high-risk conflicts.
- A significant number of medium-risk and high-risk conflicts observed with the above listed movements suggests that drivers crossing the mainline lanes may be frustrated due to higher waiting times and are willing to take more risk by selecting smaller gaps within the high-volume mainline traffic stream.
- The Eastbound Through vs. Left-Turn from Median movements result in significant number of low-risk conflicts which occurred at low-speeds. This type of conflicts suggests undesirable behaviour within the median and/or improper use of median refuge area when occupied by several vehicles at one time. Similar concerns were observed on the video footage (see **Figure 4.5.4** below) when a westbound left-turn vehicle destined to the southbound median

acceleration lane occupied the center portion of the median and conflicted with opposing traffic.

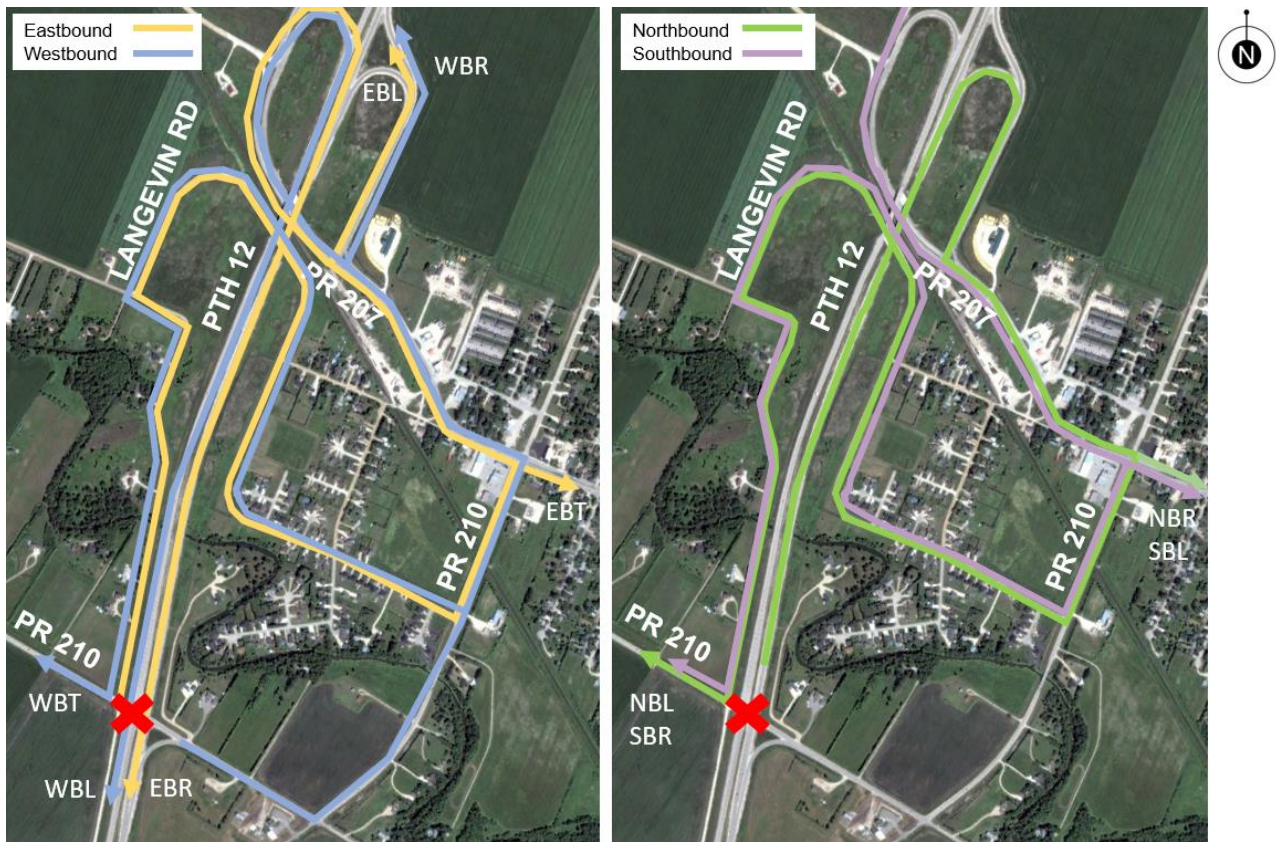
Figure 6.5.1: Re-routing of traffic with intersection full closure

Although all three options have a great potential to significantly reduce the number of potential conflicts at the PTH 12 and PR 210 intersection, the re-routing of traffic elsewhere on the local roadway network and adjacent interchange will result in increase of potential conflicts elsewhere (i.e., at crossing points elsewhere along the local roadway network due to increase in traffic volumes).

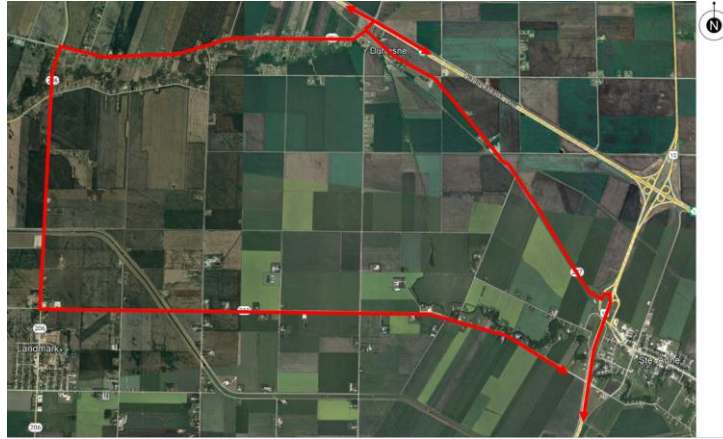
*Figure 6.5.2: Alternative route for trucks*

The majority of the proposed re-routing route includes gravel roadway and would need to be upgraded if it were to accommodate heavy trucks. Alternatively, truck traffic could use PR 206 and PR 207 to connect to PTH 12, which would result in a substantial detour (see **Figure 6.5.2**).

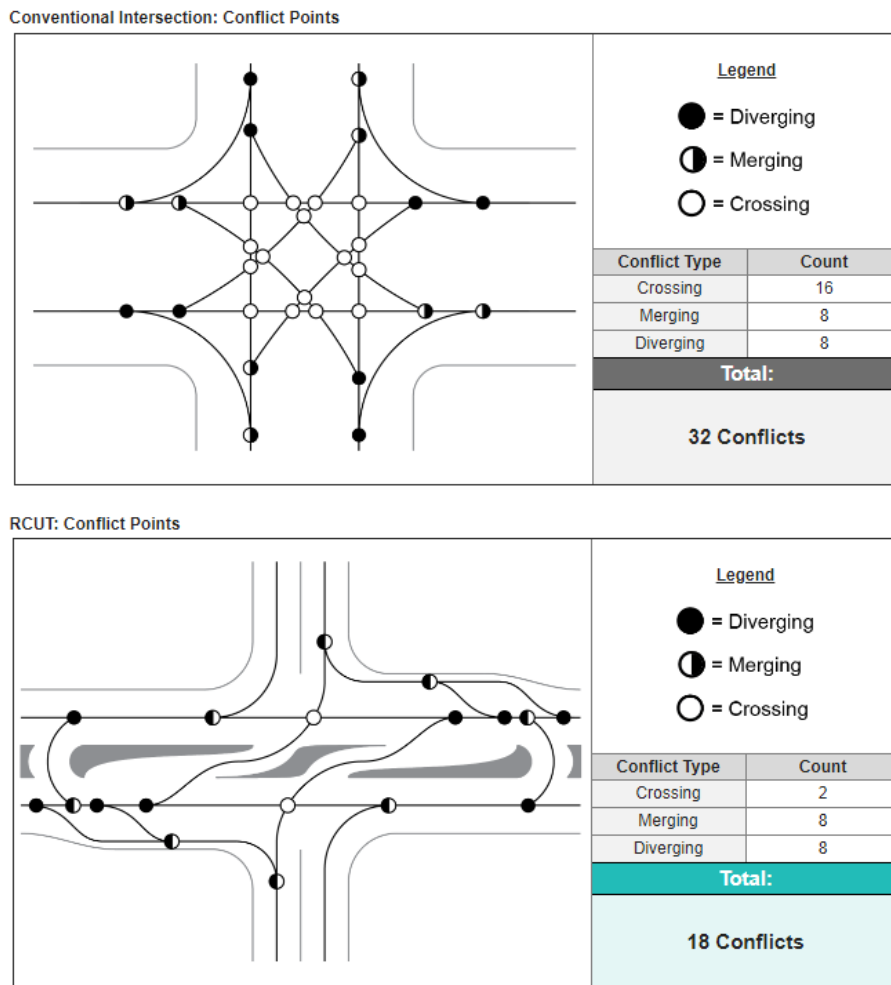
Figure 6.6.3: Conventional intersection and RCUT intersection conflict points

By restricting several movements at the main crossing intersection, RCUT intersections reduce vehicular intersection conflict points from 32 to 18, including the conflict points introduced at the median U-turn crossovers, as shown in the figure below.

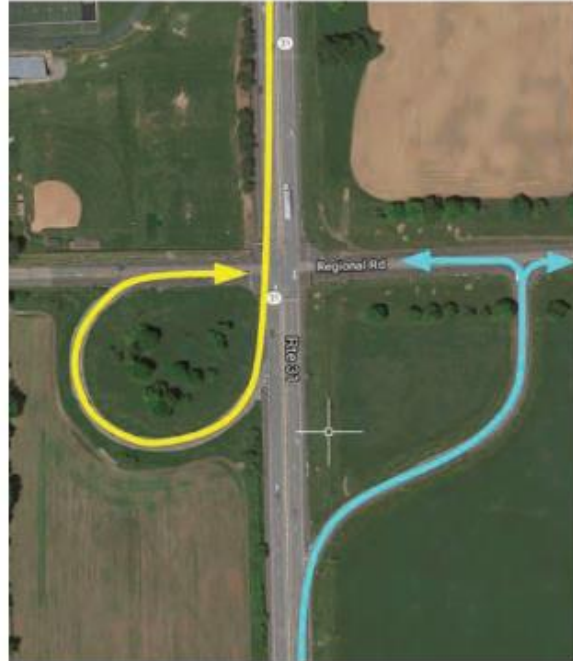
Figure 6.6.6: Jug-handle intersection

Jug-handles redirect left-turning movements at the main intersection using two types of turning movements as shown in the figure below. In the first type of turning movement, left-turn vehicles exit to the right using a connector and then turn left to complete their desired movement. The other type of turning movement requires left-turning traffic to pass through the intersection, exit via a connector (which loops around to the right), and then transverses the intersection as part of the through movement.

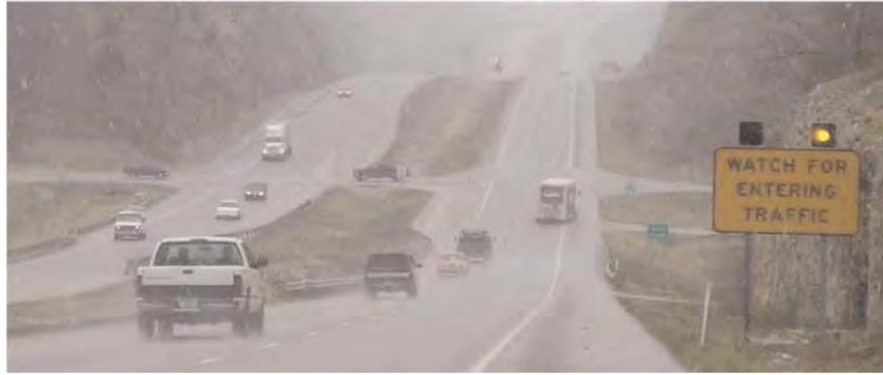
Figure 7.3.1: Example of a Dynamic Advance Intersection Warning System

- Consider installing a Dynamic Advance Intersection Warning System: A Dynamic Advance Intersection Warning System is an intersection recognition treatment that is meant to enhance an expressway driver's awareness of an approaching two-way stop-controlled intersection. The systems typically consist of static Vehicle Entering When Flashing (VEWF) warning signs with traffic-actuated flashers on the expressway approaches and in-pavement loop detectors on the minor roads. When traffic is detected on the minor road, the flashers on the VEWF signs are activated on the expressway approaches, warning expressway drivers that one or more vehicles are present at the intersection and may enter from the minor road.

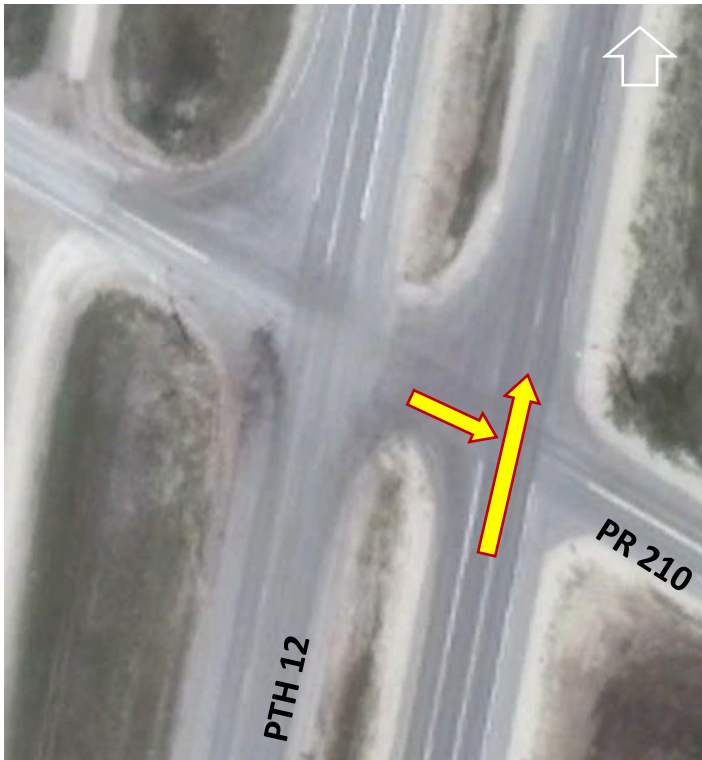
**1. Northbound Through vs. Through from median (Through vs. Through)**

| Risk Level | Critical Risk | High Risk | Medium Risk | Low Risk |
| Number of Crossing Conflicts | 0 | 2 | 13 | 31 |

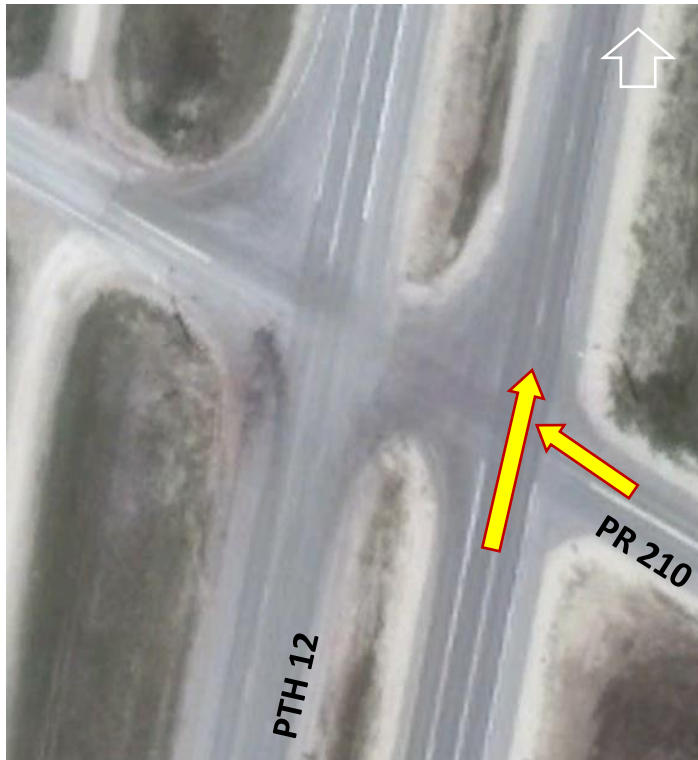
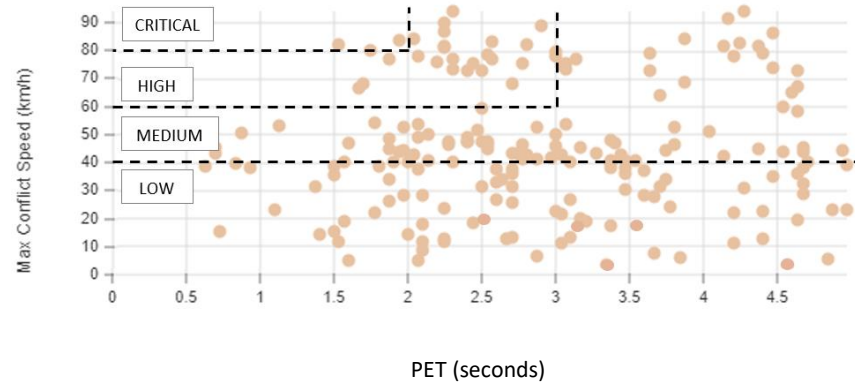
## 2. Northbound Through vs. Westbound Through (Through vs. Through)

| Risk Level | Critical Risk | High Risk | Medium Risk | Low Risk |
|---|---|---|---|---|
| Number of Crossing Conflicts | 3 | 23 | 81 | 90 |

Distribution of Conflicts

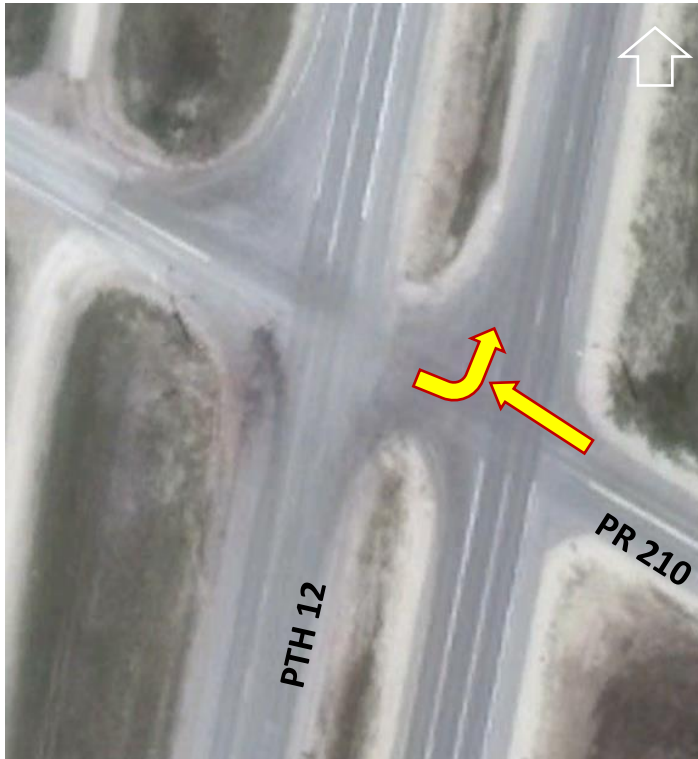
### 3. Left-Turn from Median vs. Westbound Through (Left-Turn vs. Through Oncoming)

| Risk Level | Critical Risk | High Risk | Medium Risk | Low Risk |
| Number of Crossing Conflicts | 0 | 0 | 2 | 33 |

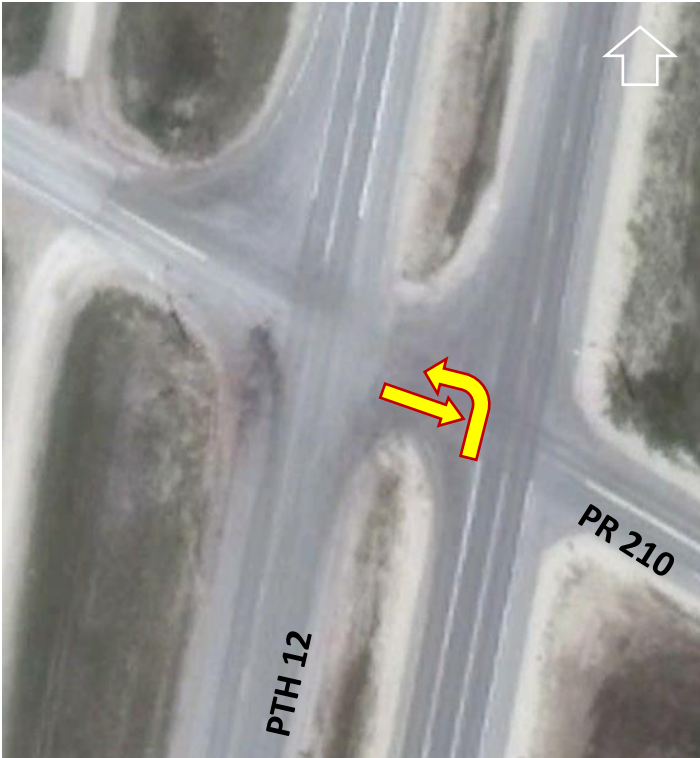
**4. Northbound Left-Turn vs. Through from Median** (*Left-Turn vs. Through from Left*)

| Risk Level | Critical Risk | High Risk | Medium Risk | Low Risk |
| Number of Crossing Conflicts | 0 | 0 | 1 | 31 |

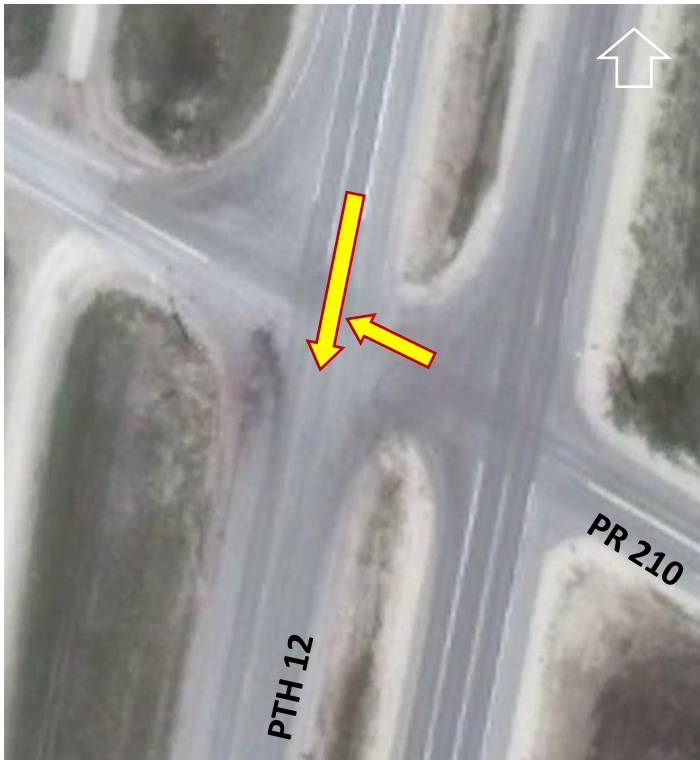
**6. Southbound Through vs. Through from Median (Through vs. Through)**

| Risk Level | Critical Risk | High Risk | Medium Risk | Low Risk |
| Number of Crossing Conflicts | 14 | 24 | 132 | 283 |

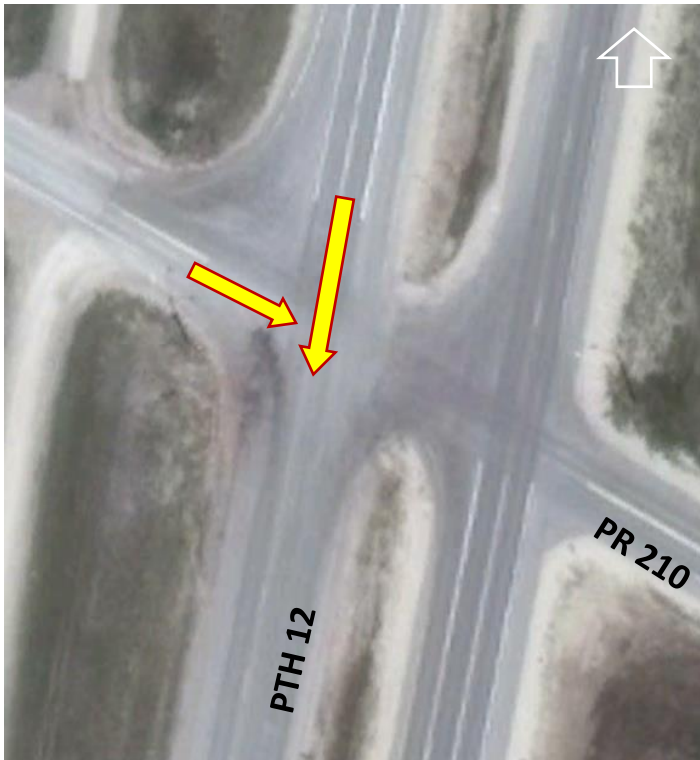
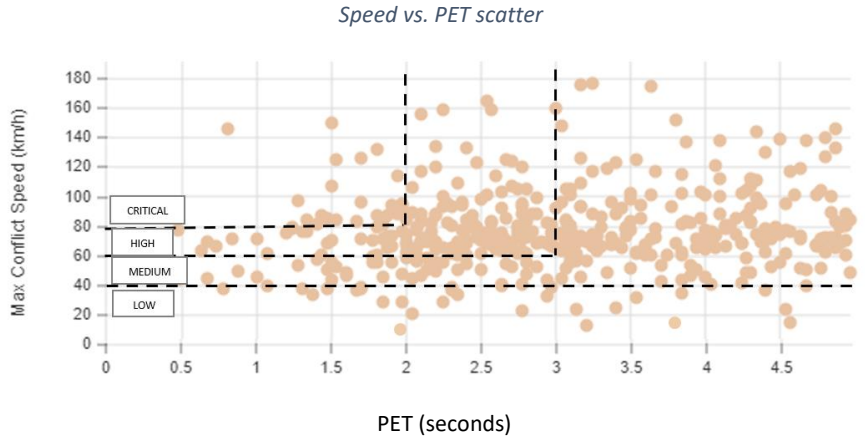
# 7. Southbound Through vs. Eastbound Through (Through vs. Through)

| Risk Level | Critical Risk | High Risk | Medium Risk | Low Risk |
|---|---|---|---|---|
| Number of Crossing Conflicts | 23 | 130 | 277 | 24 |

Distribution of Conflicts

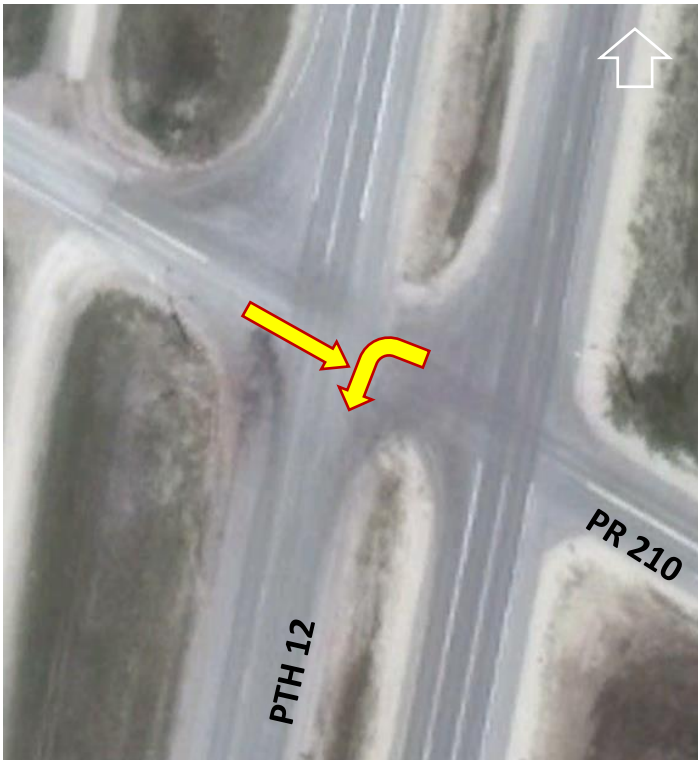
## 8. Left-turn from Median vs. Eastbound Through (Left-Turn vs. Through Oncoming)

| Risk Level | Critical Risk | High Risk | Medium Risk | Low Risk |
| Number of Crossing Conflicts | 0 | 0 | 2 | 248 |

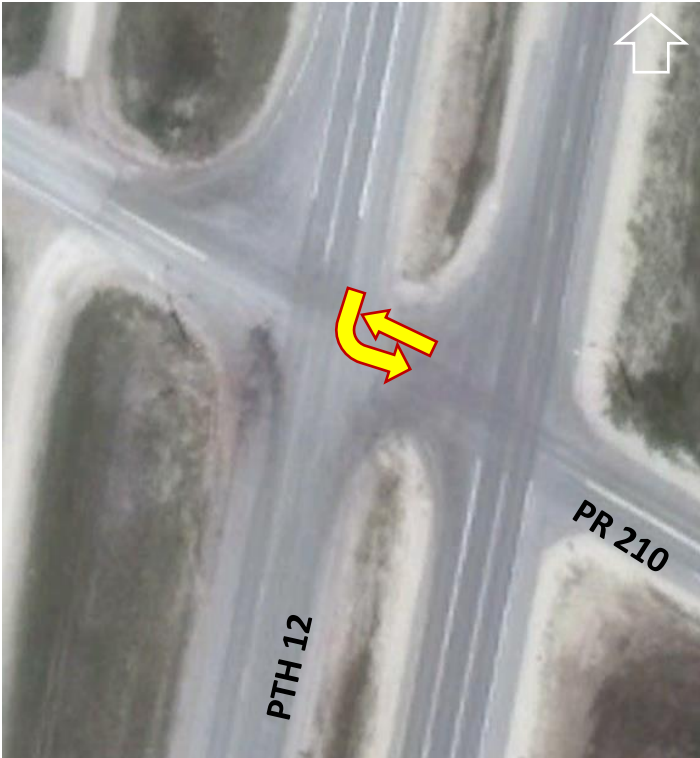
**9. Southbound Left-Turn vs. Through from Median (Left-Turn vs. Through from Left)**

| Risk Level | Critical Risk | High Risk | Medium Risk | Low Risk |
| Number of Crossing Conflicts | 0 | 0 | 1 | 13 |
